# Manhole Inspection Summary

Manhole # S53I\_\_017MH

Insp Date: **4/14/08 7:49 AM**

**Location** Address: **501 s. clinton**

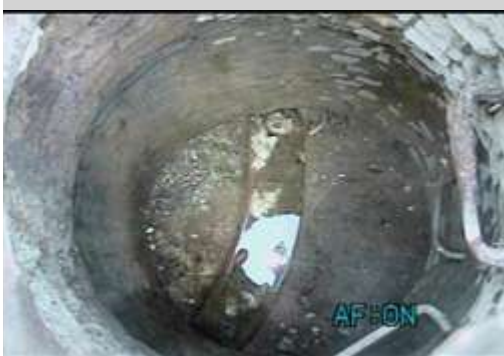
Defect 1

Condition: ☐ Sound ☐ Cracked ☐ Root Intrusion ☐ Loose Brick ☒ **Deteriorated**

Infiltration: ☐ None ☐ Joint ☐ Cracks ☒ **Mortar** ☐ Roots ☐ Wall

Condition: ☐ Sound ☐ Cracked ☐ Root Intrusion ☐ Deteriorated ☐ Leaks ☒ **Debris**

corroded steps, barrel infiltration through wall, corbel deteriorated, bench and channel debris

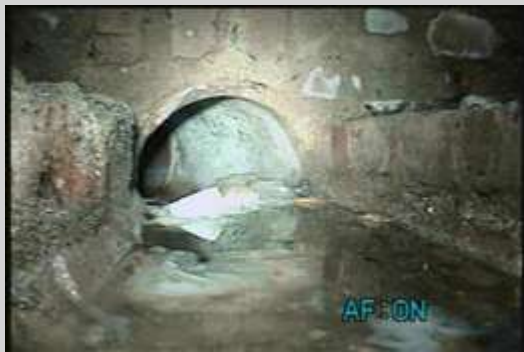
12 O'Clock Outflow

8 in. Circular Gravity Sewer  
Pipe Out @ 12 O'Clock

Invert Depth: 7.20 (ft.) Flow Characteristics: **Slow**

Deposits: ☒ None ☐ Mud ☐ Sludge ☐ Debris ☐ Grease

Infiltration: **None** Pipe Seal Cond: **Unknown**

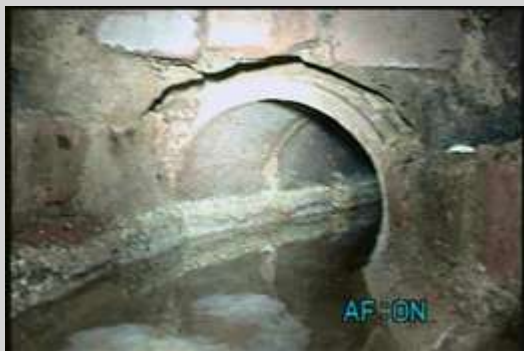
7 O'Clock Inflow

8 in. Circular Gravity Sewer  
Pipe In @ 7 O'Clock

Invert Depth: 6.66 (ft.) Flow Characteristics: **Slow**

Deposits: ☒ None ☐ Mud ☐ Sludge ☐ Debris ☐ Grease

Infiltration: **None** Pipe Seal Cond: **Unknown**
